FLOOD PLAIN INFORMATION

ASHLAND, NEBRASKA
SALT CREEK
WAHOO CREEK

PREPARED FOR
CITY OF ASHLAND STATE OF NEBRASKA

DEPARTMENT OF THE ARMY, OMAHA DISTRICT, CORPS OF ENGINEERS, 68102

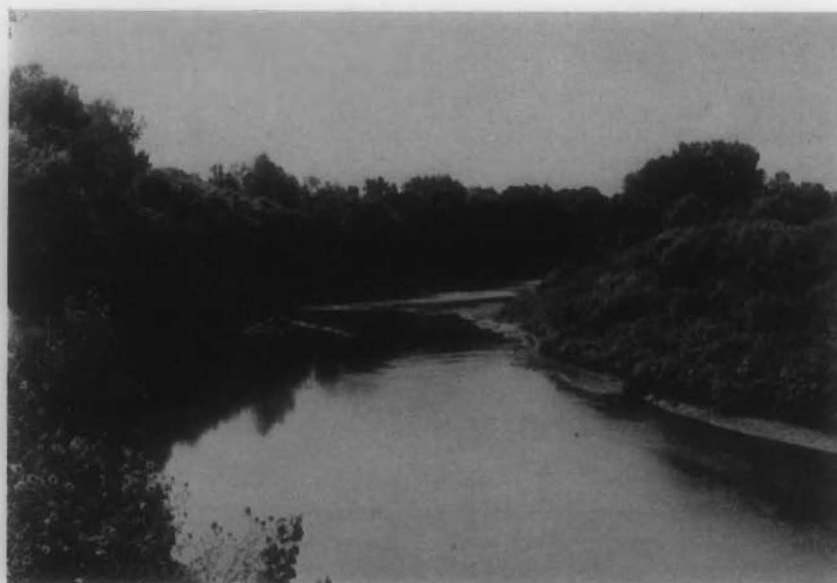
Figure 2. Salt Creek improved channel
looking downstream from west
line of Section 10, T12N, R9E

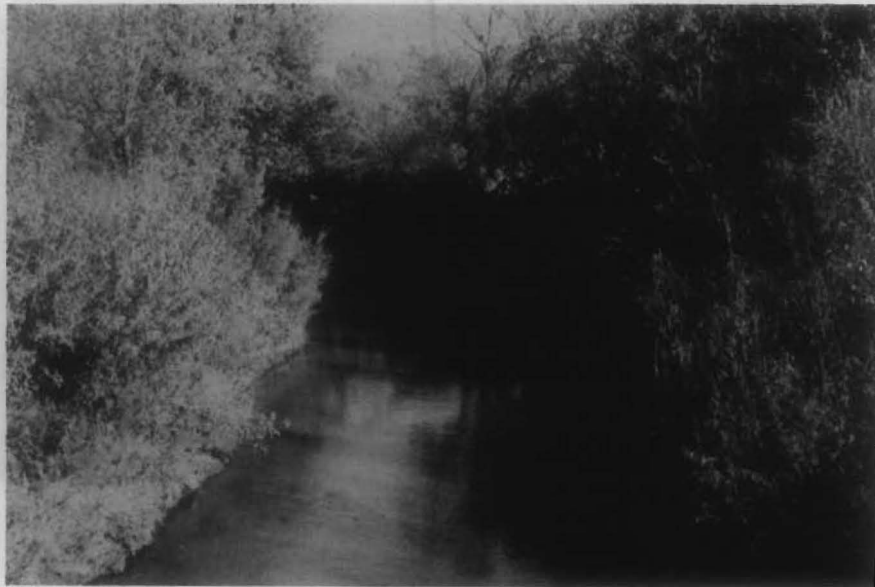
Figure 5. Wahoo Creek channel
looking east from
Nebraska State Highway 63

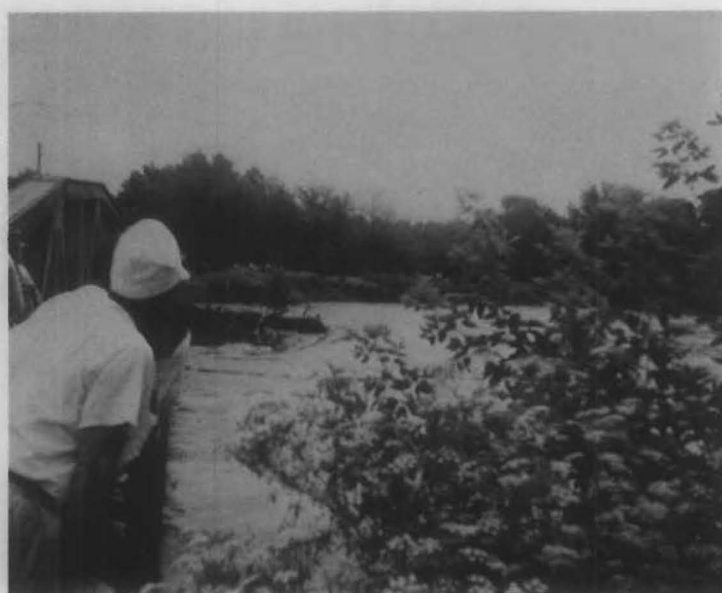
Figure 13. 1964 flood, debris at 13th Street bridge

Obstructions - During floods, debris collecting on bridges could decrease their carrying capacity and cause greater water depths (backwater effect) upstream of these structures. Since the occurrence and amount of debris are indeterminate factors, only the physical characteristics of the structures were considered in preparing profiles of the Intermediate Regional and Standard Project Floods. Similarly, the maps of flooded areas show the backwater effect of obstructive bridges, but do not reflect increased water surface elevation that could be caused by debris collecting against the structures, or by deposition of silt in the stream channel under structures. The water surface profiles show the effect of the structures on flood flows. Raised roadways as well as buildings on the flood plain will also tend to obstruct flows.

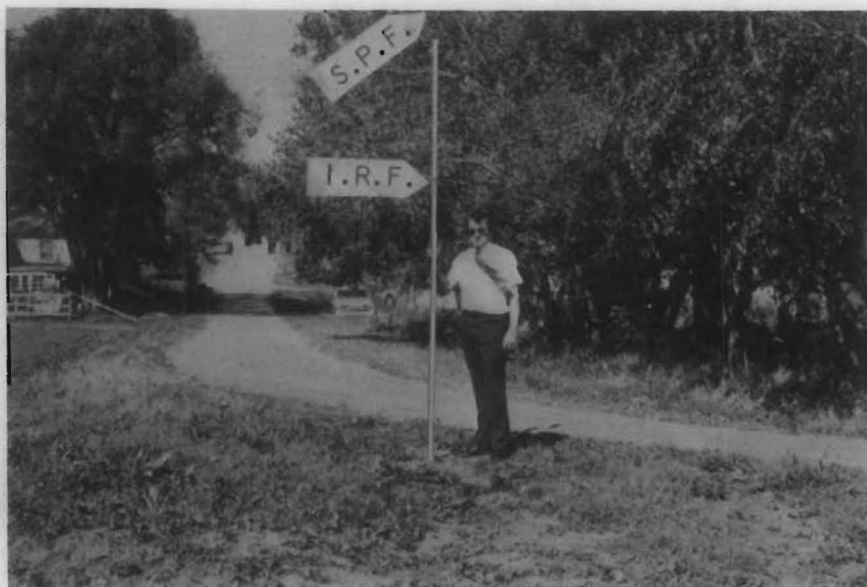
Figure 15. Depth of potential floods -
14th and Cedar Streets

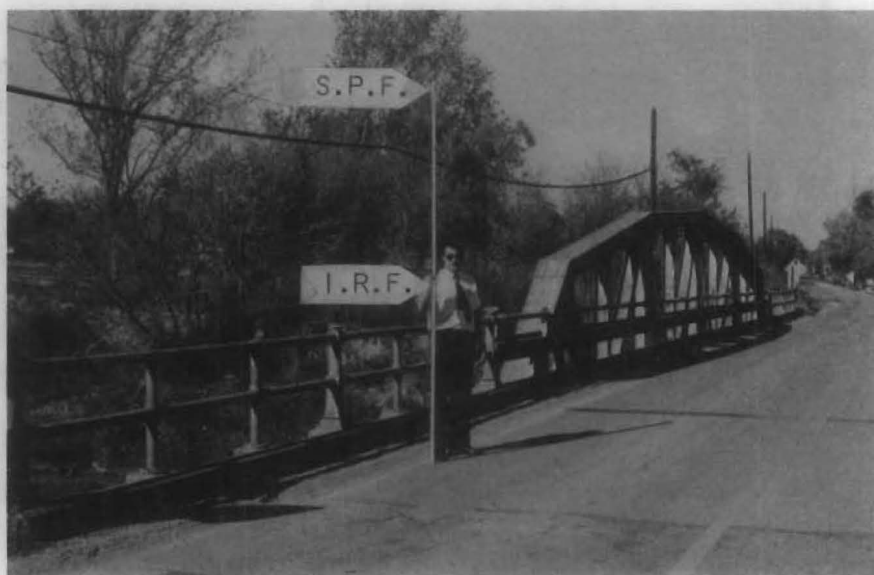
Figure 16. Depth of potential floods -
13th Street Bridge

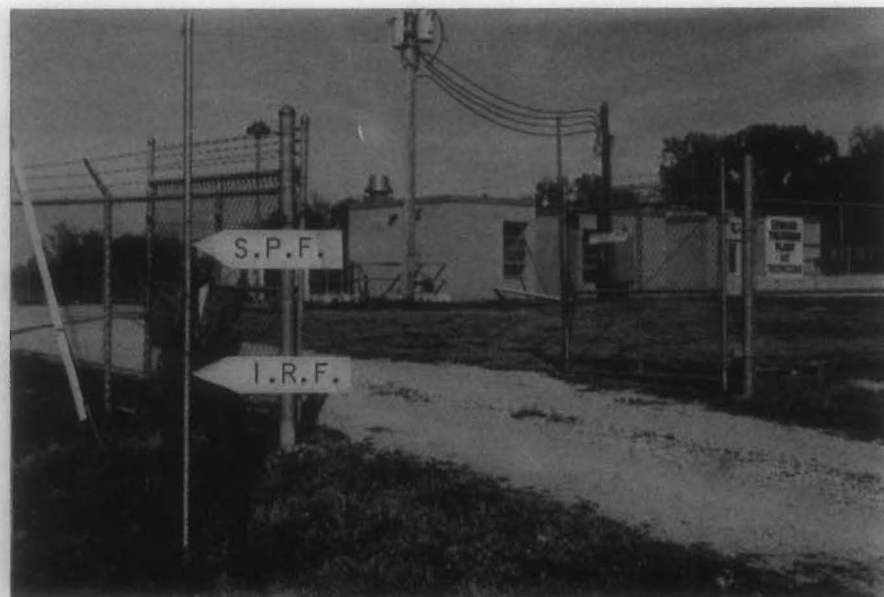
Figure 18. Depth of potential floods - Ashland
Municipal Sewage Treatment Plant

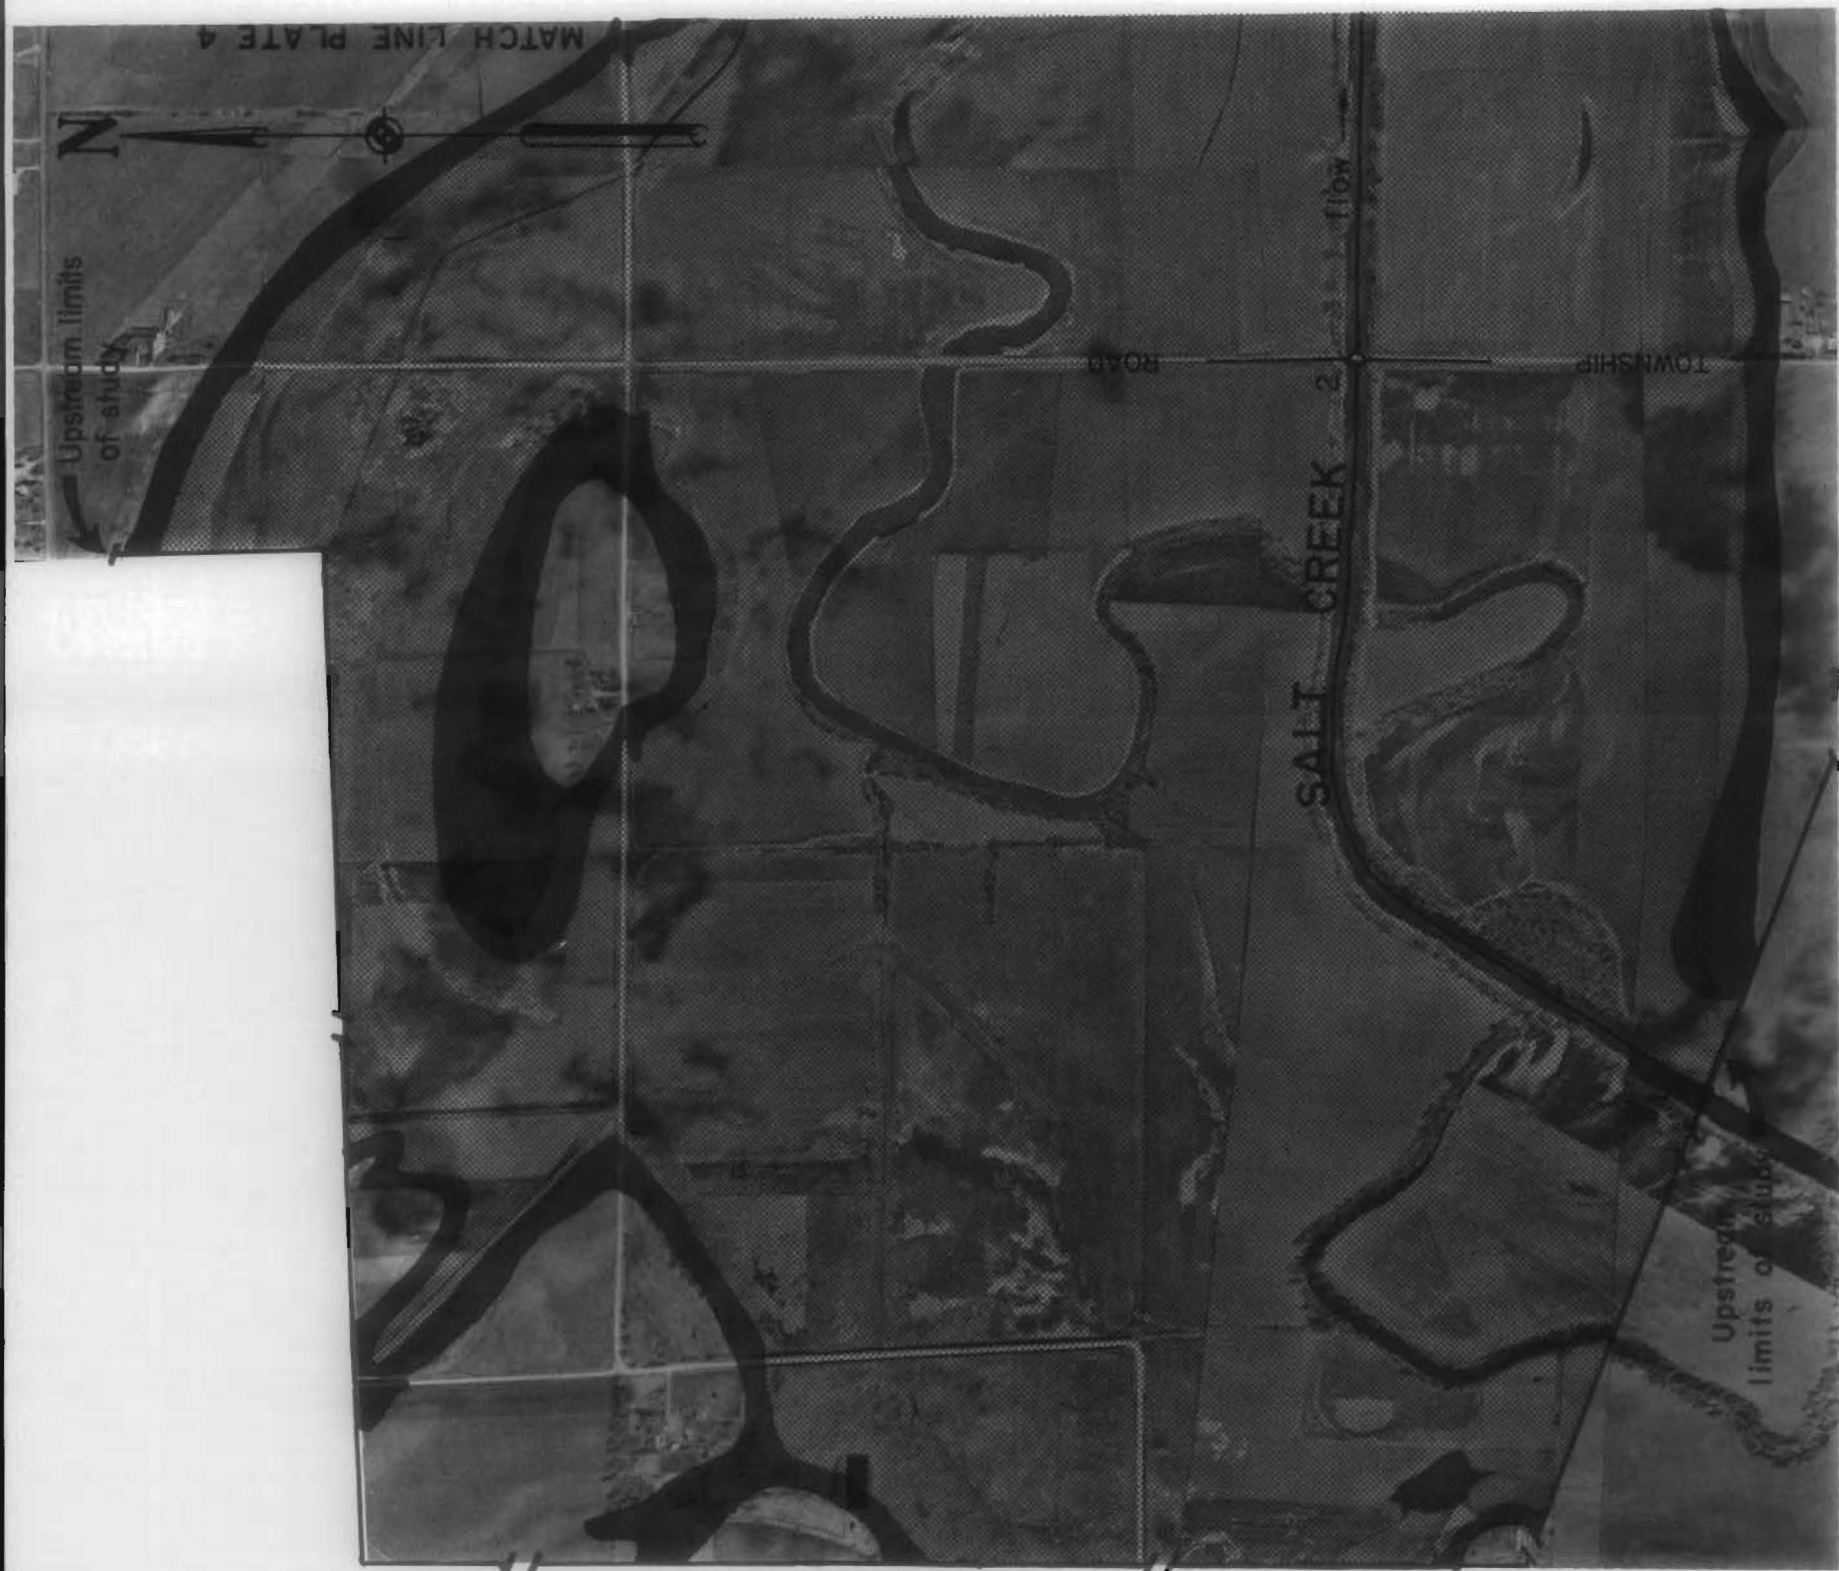
SALT CREEK BASIN
ASHLAND, NEBRASKA
**SALT CREEK
FLOODED AREAS**

Flooded areas and flood damages - The areas along the study reach that would be flooded by the Intermediate Regional Flood and the Standard Project Flood are shown on plates 3 through 6. Water surface profiles for these floods were determined using the backwater computer program HEC-2, "Water Surface Profiles" developed by the U. S. Army Corps of Engineers. The profiles on plates 7 and 8 show the elevations of the water surfaces and water depths relative to the streambed. Plates 9 and 10 show cross sections across the flood plain and show

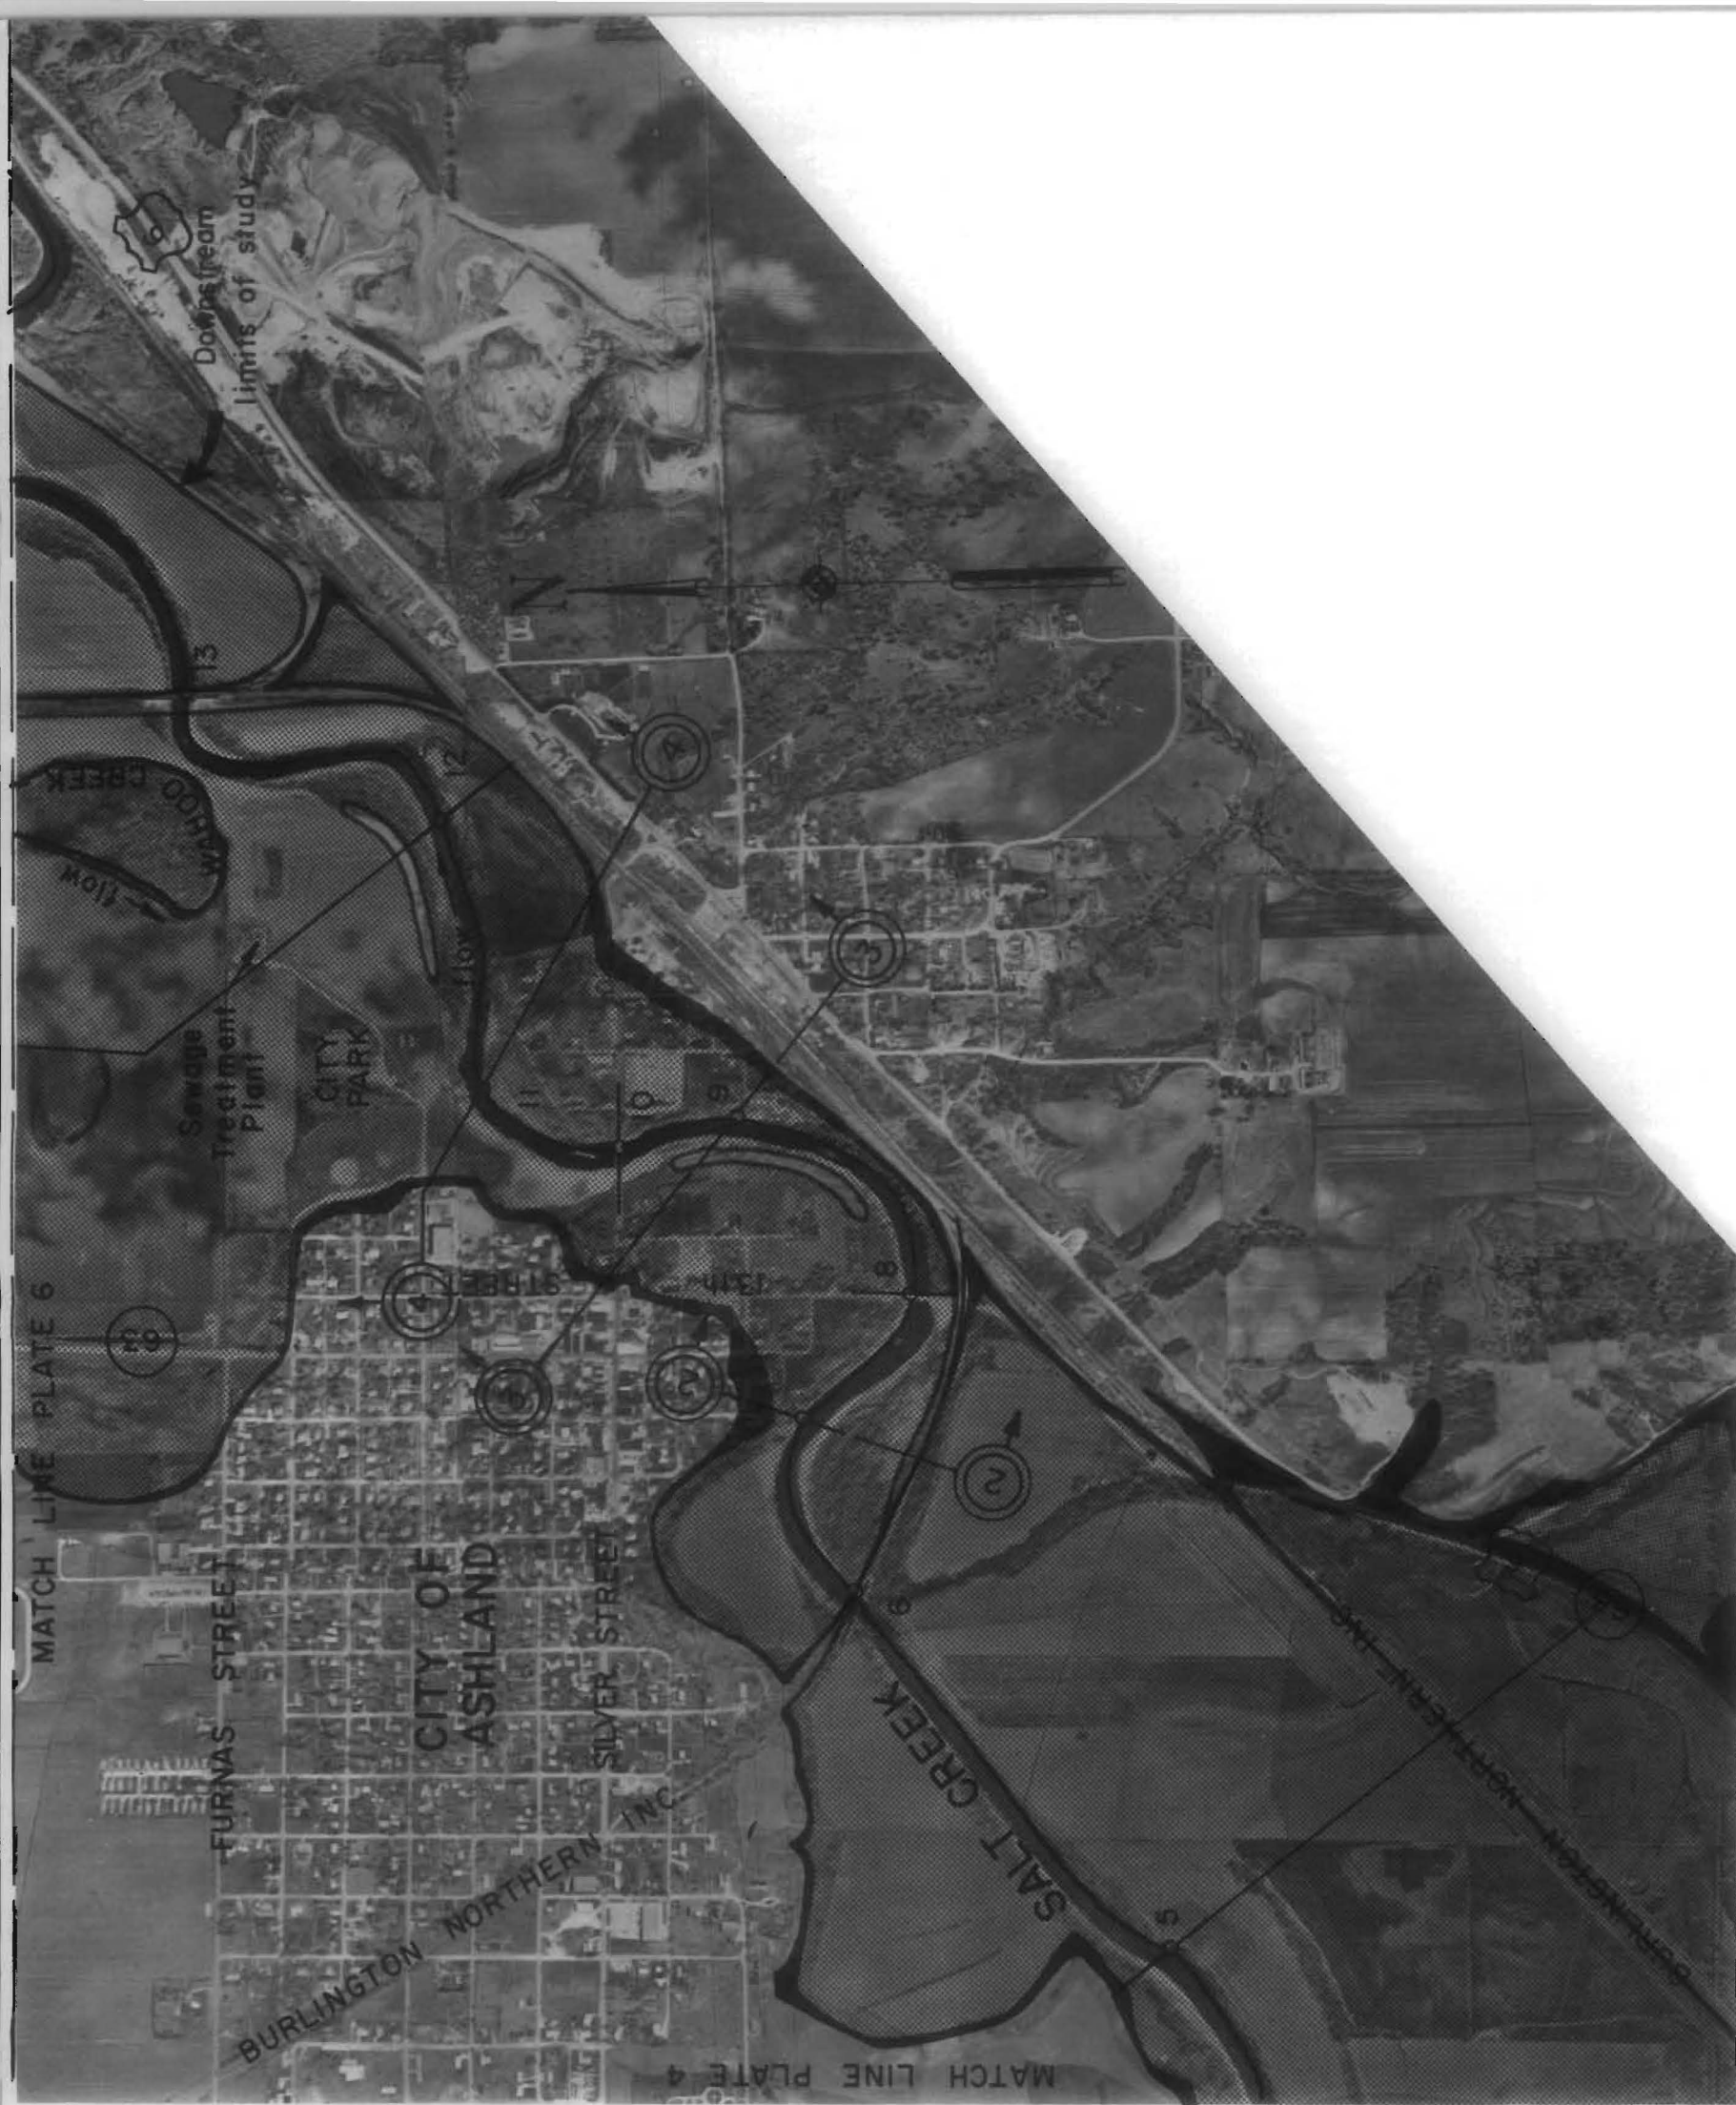
SALT CREEK BASIN
ASHLAND, NEBRASKA
**SALT CREEK
WAHOO CREEK
FLOODED AREAS**

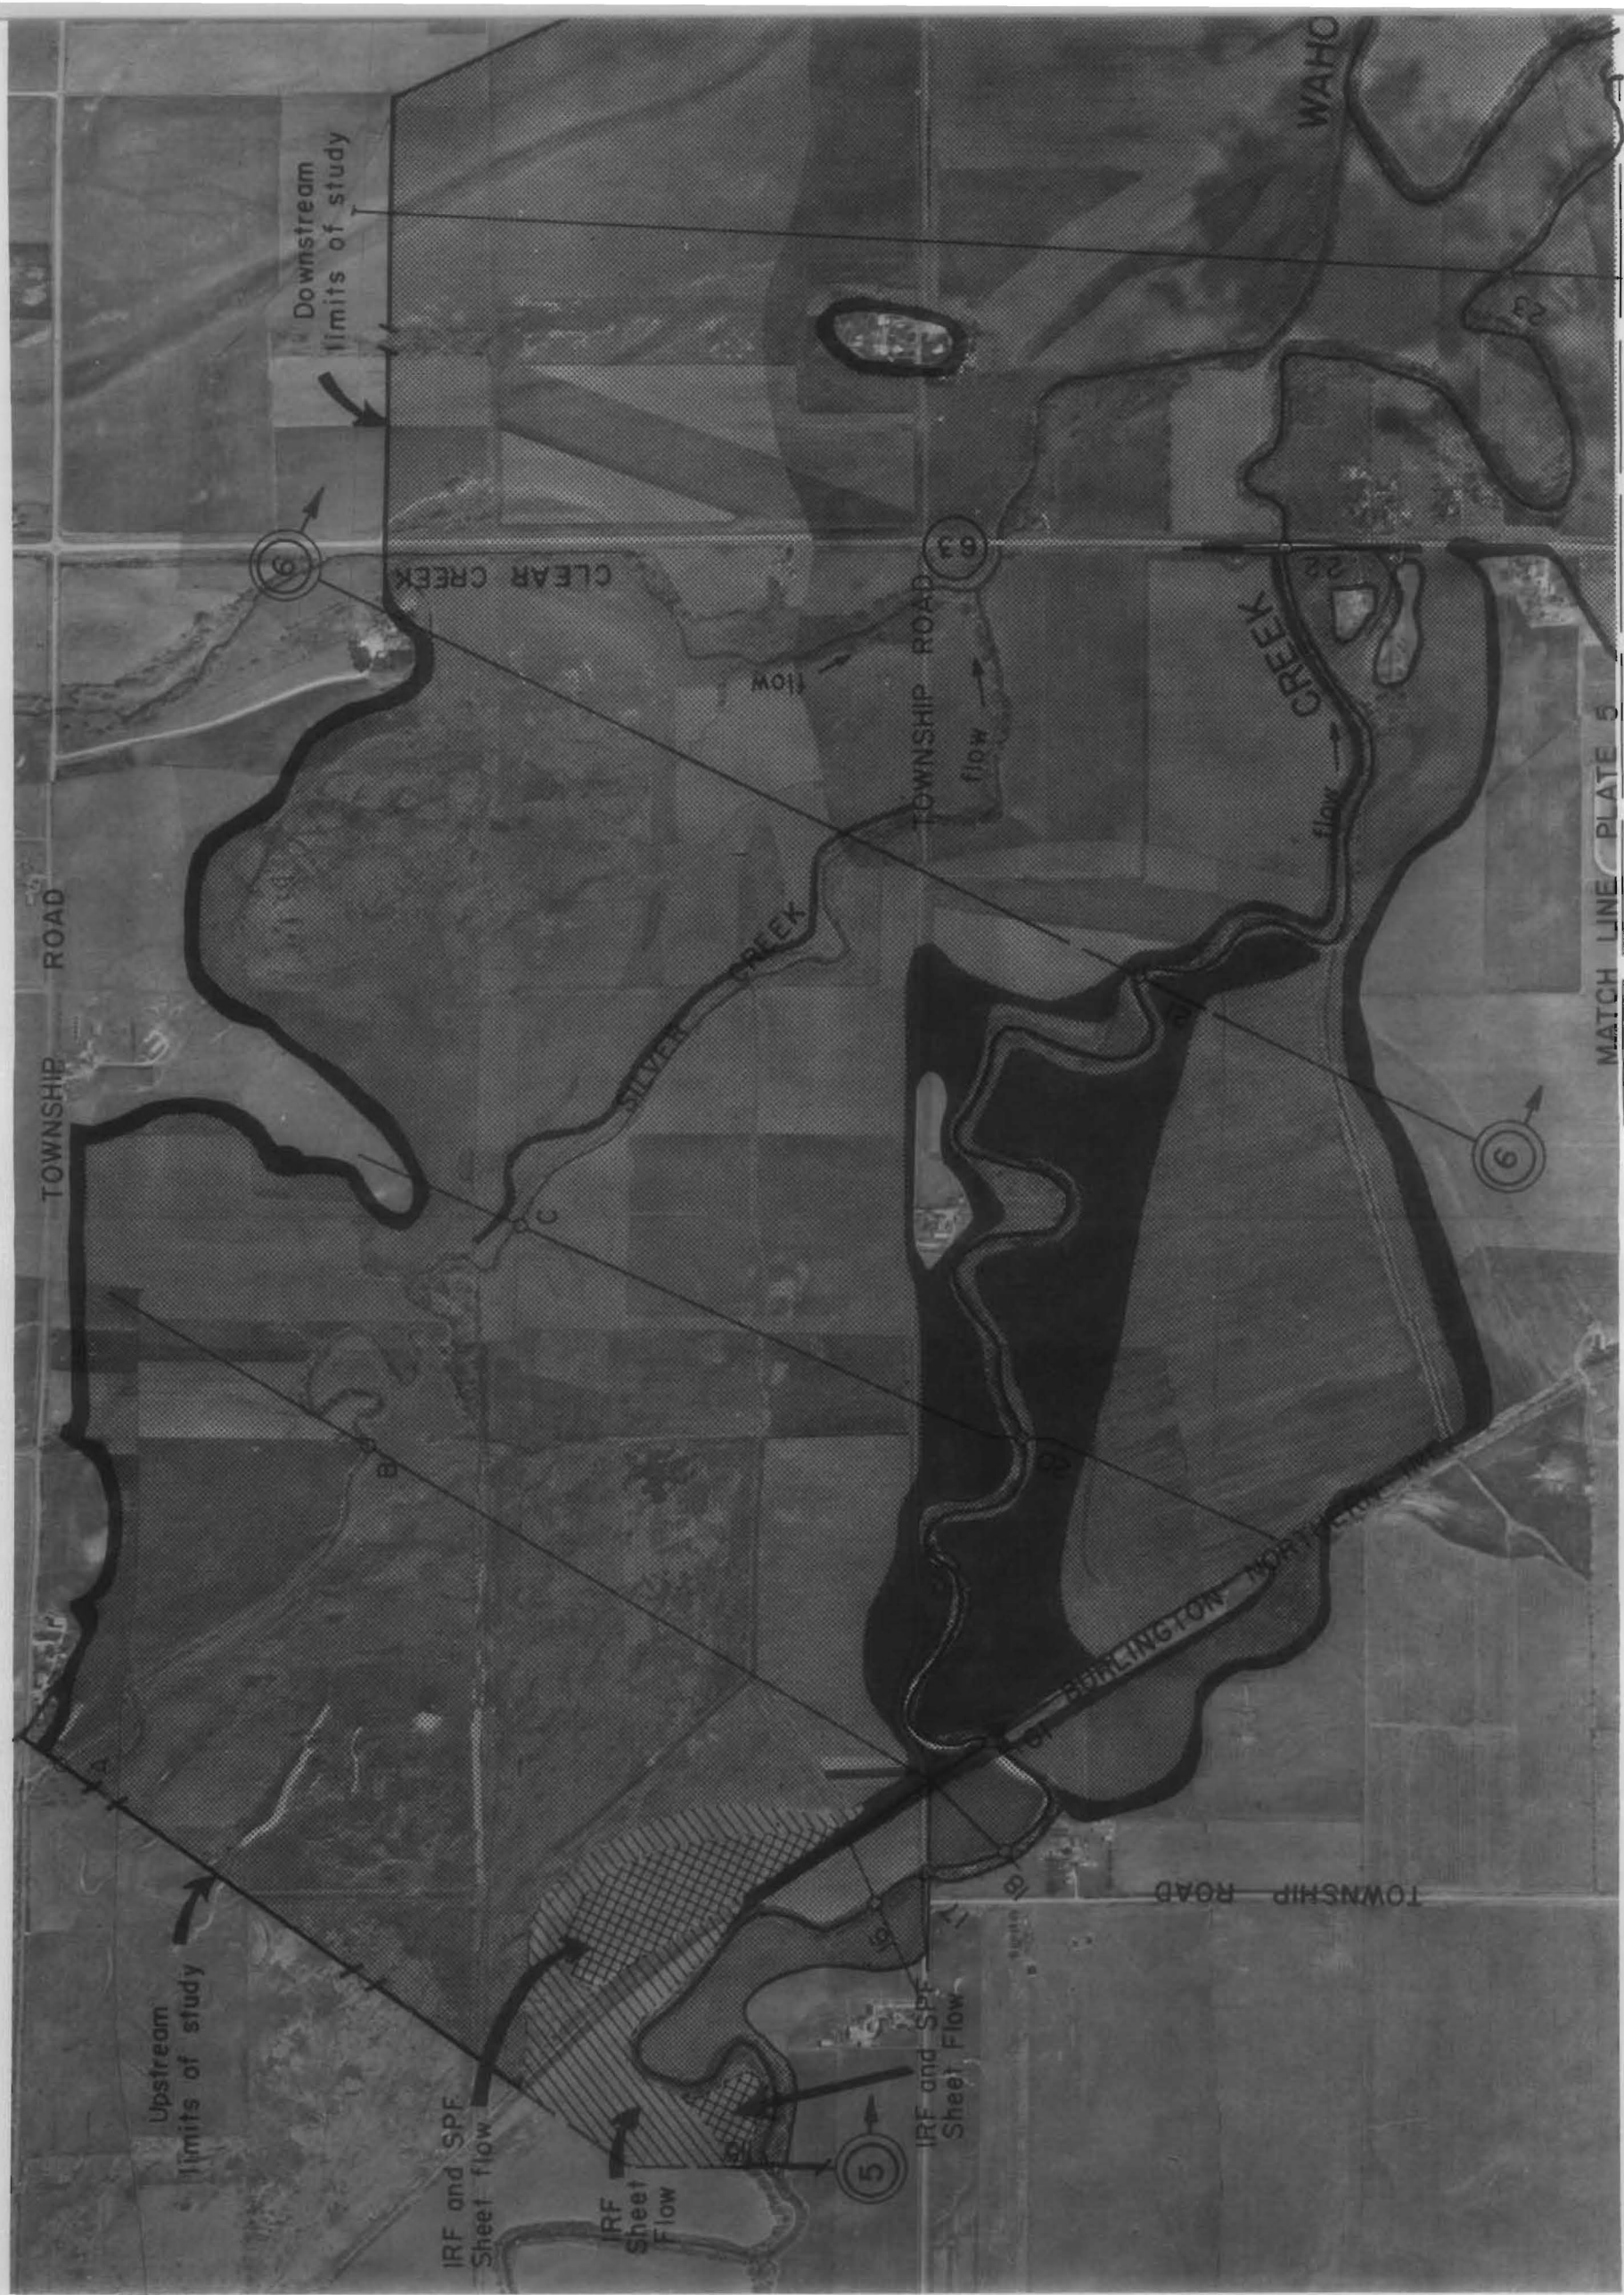
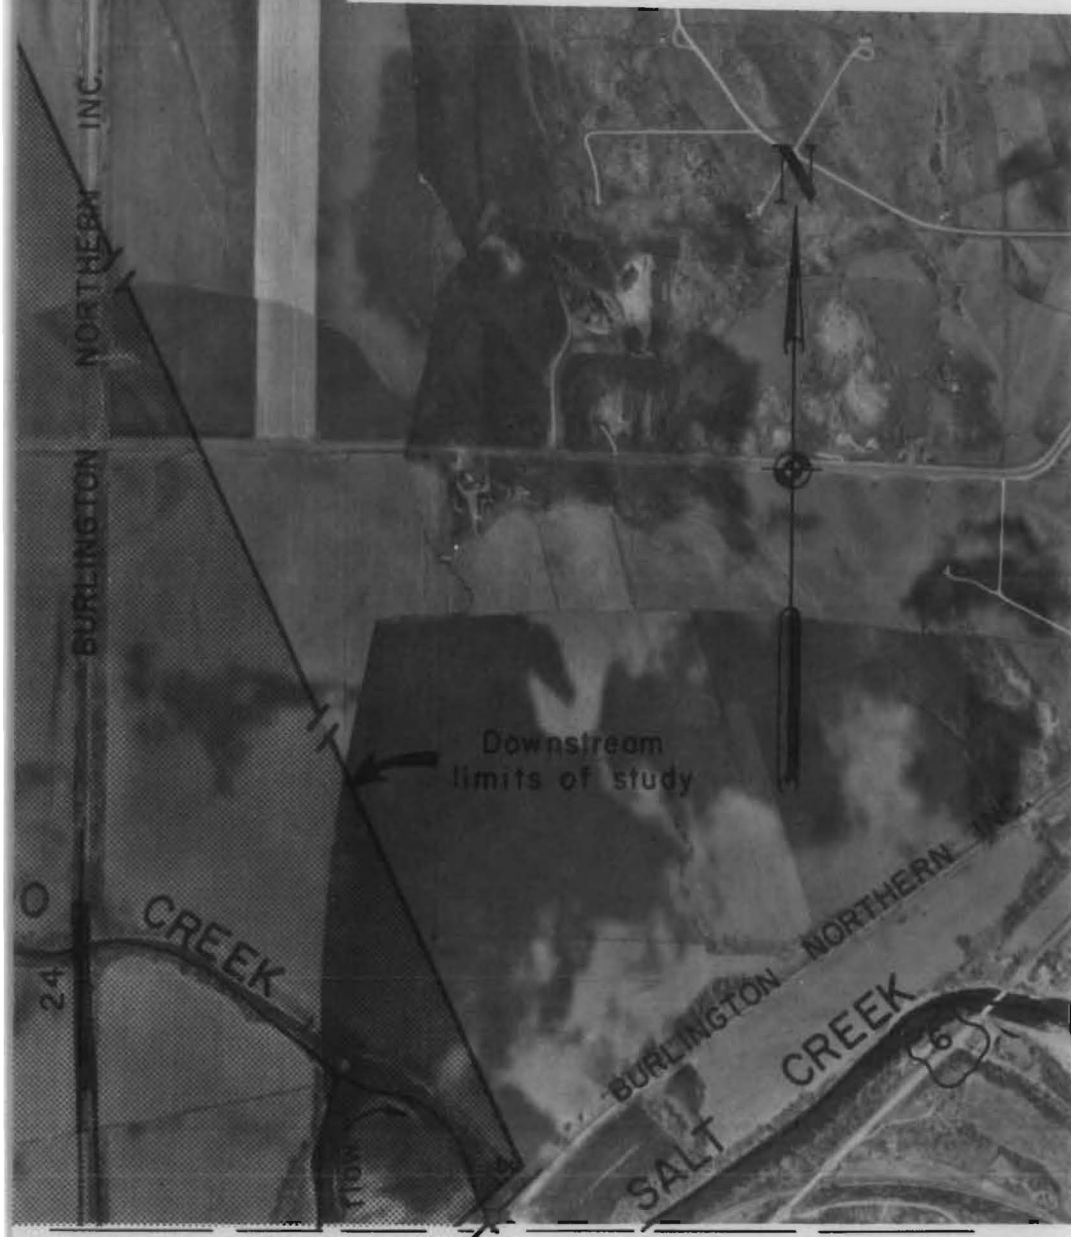
**SALT CREEK BASIN
 ASHLAND, NEBRASKA
 SALT CREEK
 PROFILE**
